Hawthorne Meadow Feasibility Study

The Town of Amherst office of Conservation and Development

By: Coldham & Hartman Architects 49 South Pleasant Street Amherst MA 01002

June 19th 2012

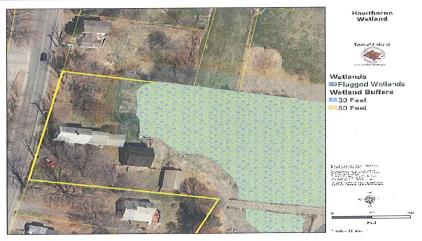
As can be seen from wetlands map of the property, part of the garage and barn are within the 30 ft no-work zone, while much of the barn and house are within the 30-50 ft buffer zone, and therefore any work on the house and barn is clearly under the jurisdiction of the Conservation Commission, and would require a Notice of Intent (NOI) (A NOI would be required even if the buildings were within a 100 ft. of the wetland boundary)

It is common practice to allow the demolition and new construction of a new structure within the no-build and buffer zone as long as it is in the same footprint. An expansion of the footprint toward the wetland could result in a denial by the Conservation Commission or a request for some type of mitigation. Demolition of the existing non-conforming building and constructing new further from the wetland (i.e. south of the existing house), but even still in the buffer zone, would presumably be seen as favorable by the Conservation Commission.

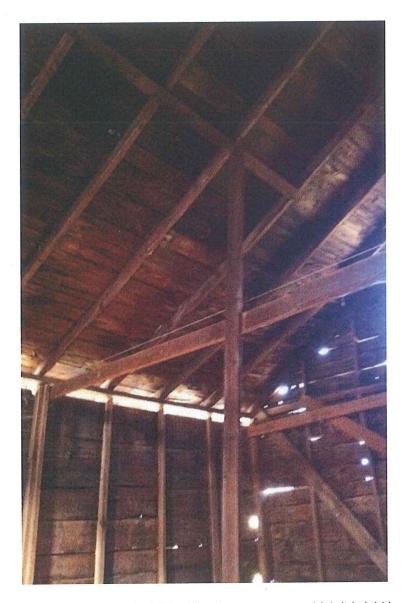
The floor structure in 60% of the floor area over which it is laid is completely collapsing and/or decayed.

Ryan Hellwig PE in his structural review of the buildings on the site (attached as Appendix B) concludes as follows: "The barn is in such bad shape that it would cost more money to save them than to tear it down and build new to better suit the proposed use". (See Appendix G for further photographs of these existing conditions)
